# TECHNICAL SERVICE BULLETIN

| TF16-001G | NTB17-003G | December 10, 2024 |

## FLUID LEAK CAUSED BY TRANSFER ASSEMBLY RIGHT SIDE DRIVE SHAFT OIL SEAL

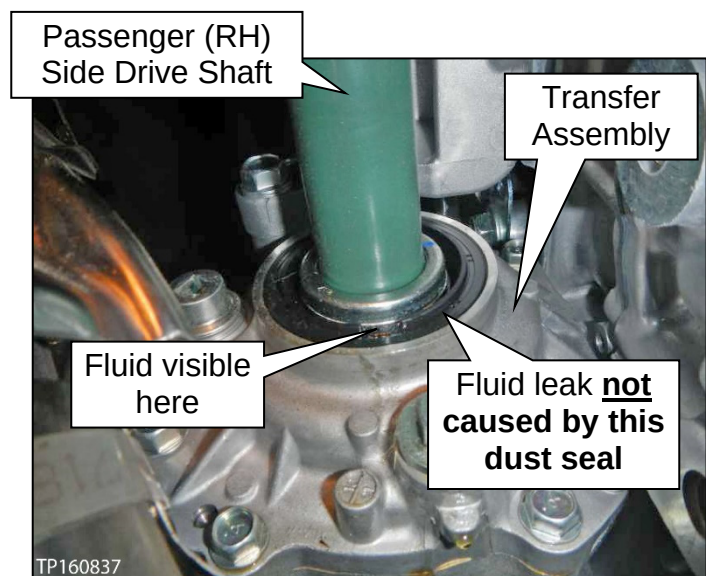
Figure 1

If fluid is leaking from the front passenger (RH) side of the Transfer Assembly, refer to the information in this bulletin.

- The fluid leak is NOT caused by the dust seal shown in Figure 1.
- This repair does NOT require Transfer Assembly removal from the vehicle.

1. **DO NOT REPLACE** the Transfer Assembly.
2. Replace the drive shaft oil seal and the dust seal.
  - Refer to NTB21-094 for drive shaft oil seal and dust seal replacement.

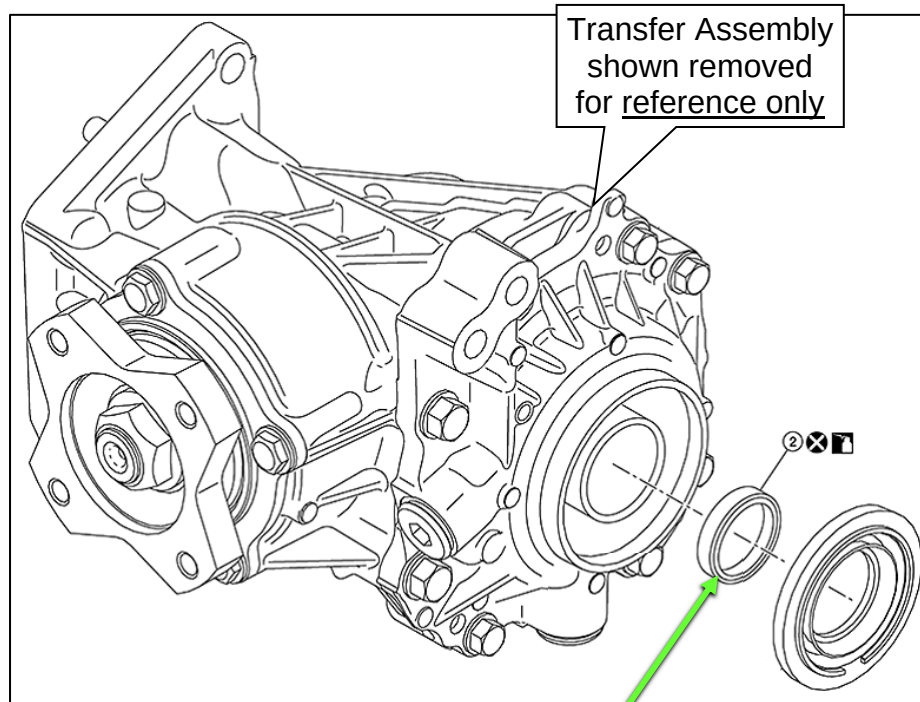
- This repair does NOT require Transfer Assembly removal from the vehicle.
- This repair does NOT require transfer cover removal from the Transfer Assembly.
- Figure 7 only shows the Transfer Assembly removed for reference only.

Fluid leak caused by this seal (33114-xxxxx);  
drive shaft oil seal / ring gear shaft oil seal

To avoid damage to the Transfer Assembly and the new seals, use an appropriate seal installer and seal protector during the repair.

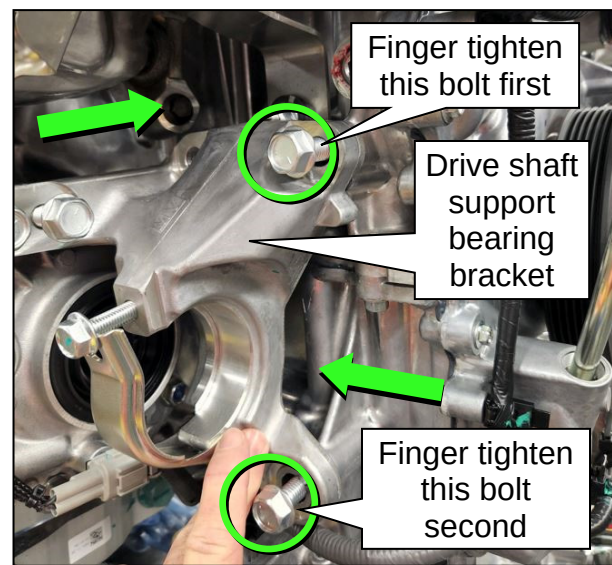
Figure 9

To avoid leak recurrence and damage to the Transfer Assembly and new seals, follow the sequence below on 2019-2024 Altima and 2021-2023 Rogue vehicles for drive shaft support bearing bracket reinstallation.

1. Place and hold the drive shaft support bearing bracket into position, ensuring it is flat against the engine block and transfer assembly, and loosely install the bolts (Figure 9).
