SERVICE BULLETIN

EL18-022c

NTB18-081c

2017-2018 PATHFINDER AND 2018 ARMADA; SOFTWARE UPDATES FOR INFOTAINMENT ISSUES

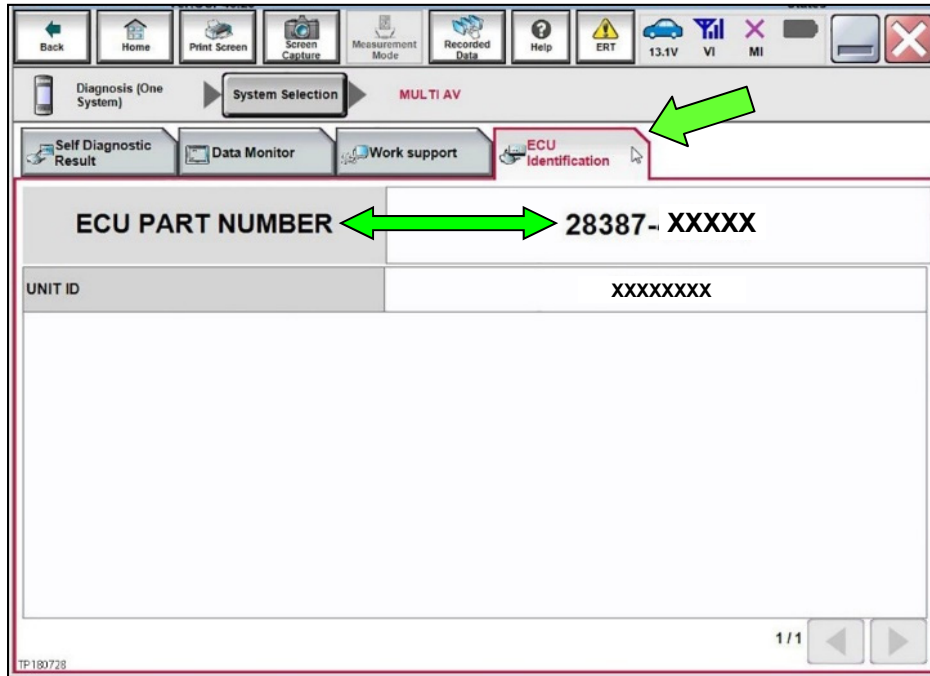
7. Select the **ECU Identification** tab.
 8. When the screen in Figure 4 displays, confirm this bulletin applies as follows:
 - a. Write down the **ECU PART NUMBER** on the repair order.
- NOTE:** This is the current DCU part number (P/N).

- b. Compare the P/N written down to the P/Ns in the **CURRENT DCU PART NUMBER** column in **Table A** below.
 - If there is a match, proceed to step 9 on the next page.
 - If there is not a match, DCU updating does not apply. Refer to ASIST for further diagnosis.
