SERVICE BULLETIN

Classification: EL20-008a	Reference: NTB20-016a	Date: May 18, 2020
------------------------------	--------------------------	-----------------------

RADIO INTERMITTENTLY REBOOTS DURING AUDIO PLAYBACK VIA BLUETOOTH CONNECTED IPHONE

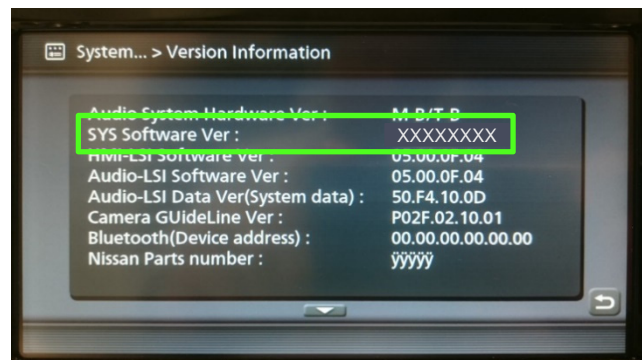
Figure 6

- If the **SYS Software Version #** is less than the numbers shown below, turn the ignition OFF and continue to step 7 on page 4.
- If the **SYS Software Version #** is equal to or greater than the numbers shown below, no software update is needed. Go to ASIST for further diagnostic and repair information.

- For 2018-2019 Sentra, Versa Note and Versa Sedan: 80856035
- For 2020 Versa Sedan and 2018-2020 Kicks: 80851035
- For 2018-2020 NV: 80856235
- For 2018-2019 Frontier: 80856135

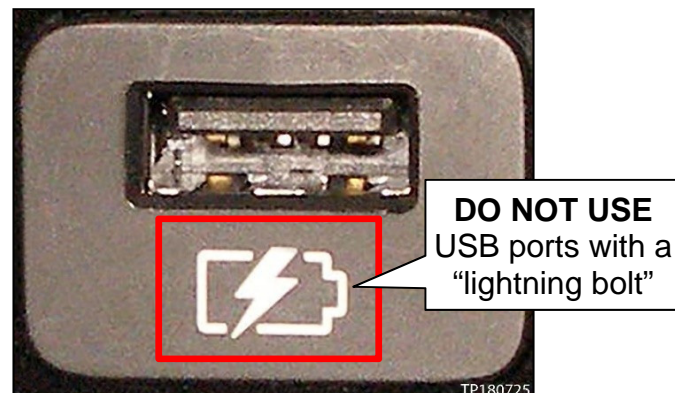
Figure 12

NOTICE Do not insert the USB drive into a charging port (Figure 12). If used, the update software and/or USB drive may become damaged. Only insert the USB drive in a USB media port.
