# TECHNICAL SERVICE BULLETIN

| TF16-001G | NTB17-003G | December 10, 2024 |

## FLUID LEAK CAUSED BY TRANSFER ASSEMBLY RIGHT SIDE DRIVE SHAFT OIL SEAL

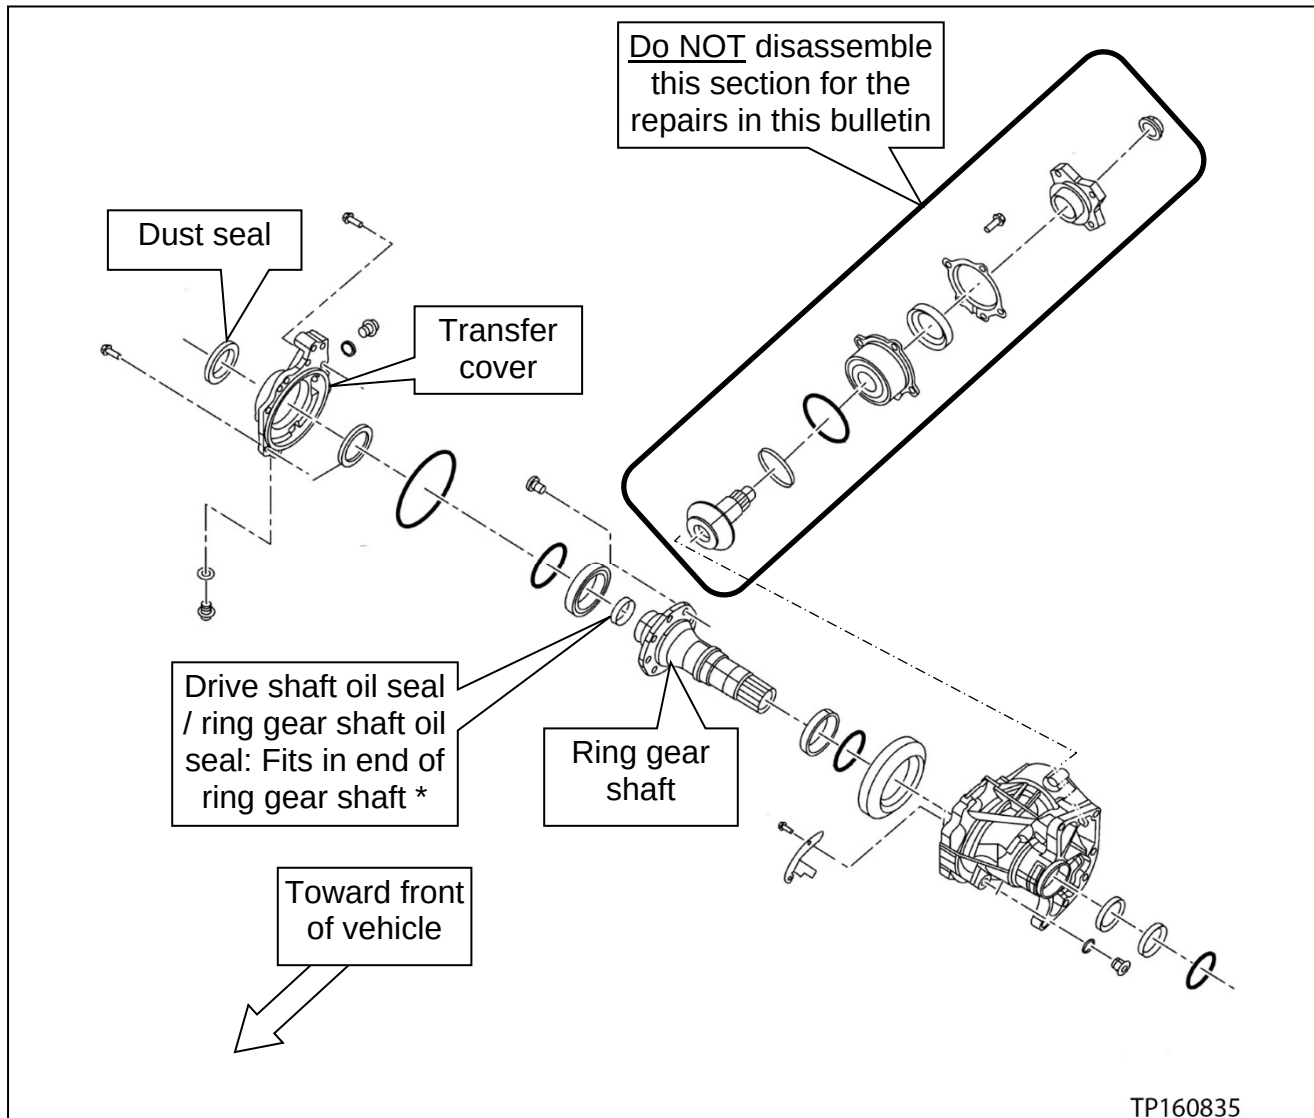
Figure 6

\* The seal causing the leak is called "Drive shaft oil seal" in the ESM for all applied models except Rogue, Rogue Hybrid, Rogue Sport, and Altima. For these vehicles, it is called "Ring gear shaft oil seal".

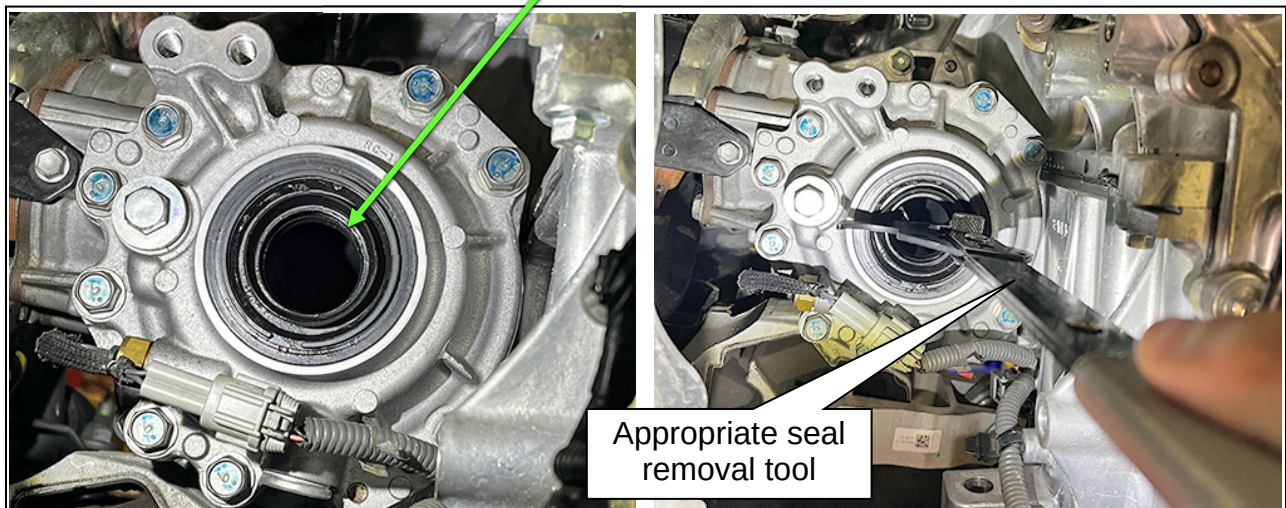
Figure 8

Fluid leak caused by this seal (33114-xxxxx);  
drive shaft oil seal / ring gear shaft oil seal

## Passenger (RH) Side Drive Shaft Oil Seal Replacement Recommendations
