# SERVICE BULLETIN

EL20-018

## SOFTWARE UPDATE FOR INFOTAINMENT ISSUES

**APPLIED VEHICLES:** 2019 Sentra (B17) – SV, SR, SL, NISMO

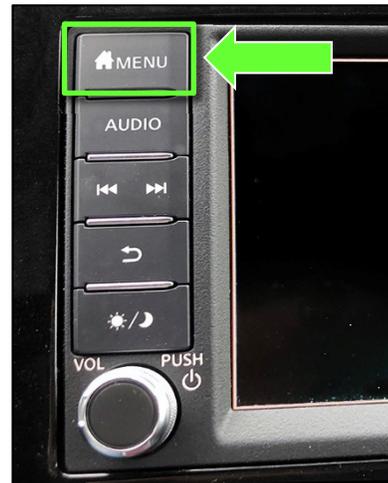
Figure 2

1. Push the **MENU** button.

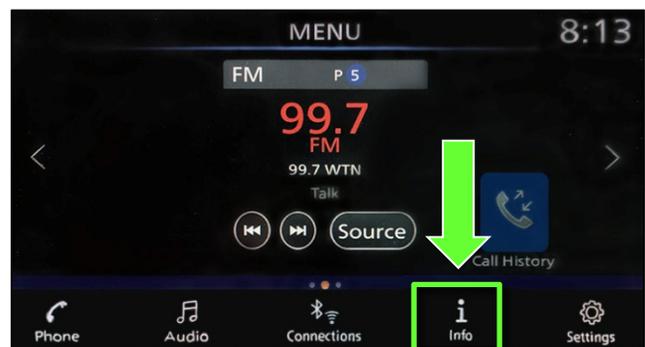
Figure 3

2. Select the **Info** icon.
  - If the Info icon does not appear as shown in Figure 3, this bulletin does not apply.

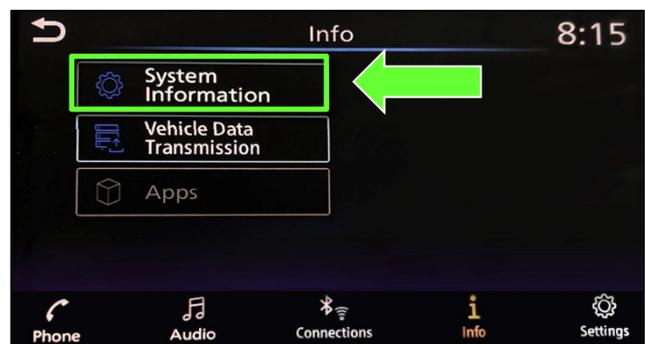
Figure 4

3. Select **System Information**.

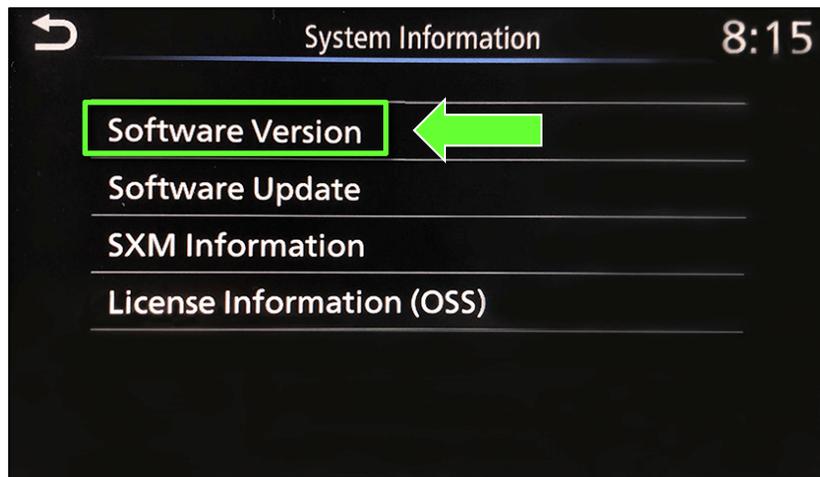
Figure 5

4. Select **Software Version**.

- If the Software version is NOT **0910 or higher**, select the back button and continue to step 5 on the next page.
- If the Software version is **0910 or higher**, select the back button, this bulletin does not apply.

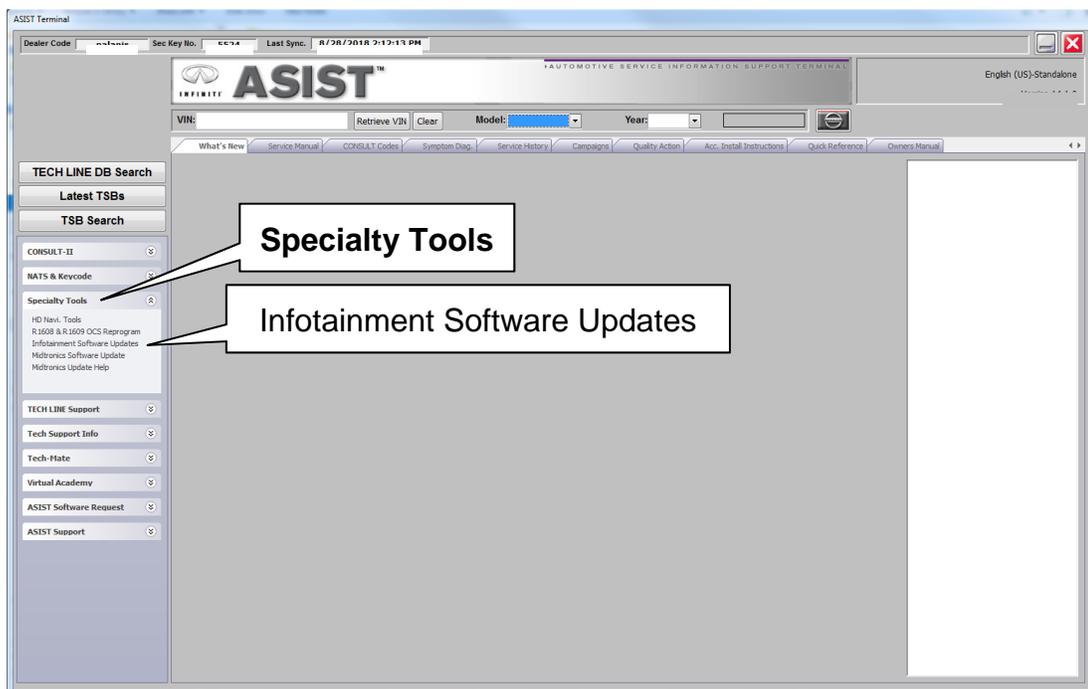
Figure 7

7. Select **Specialty Tools**, and then select **Infotainment Software Updates**.

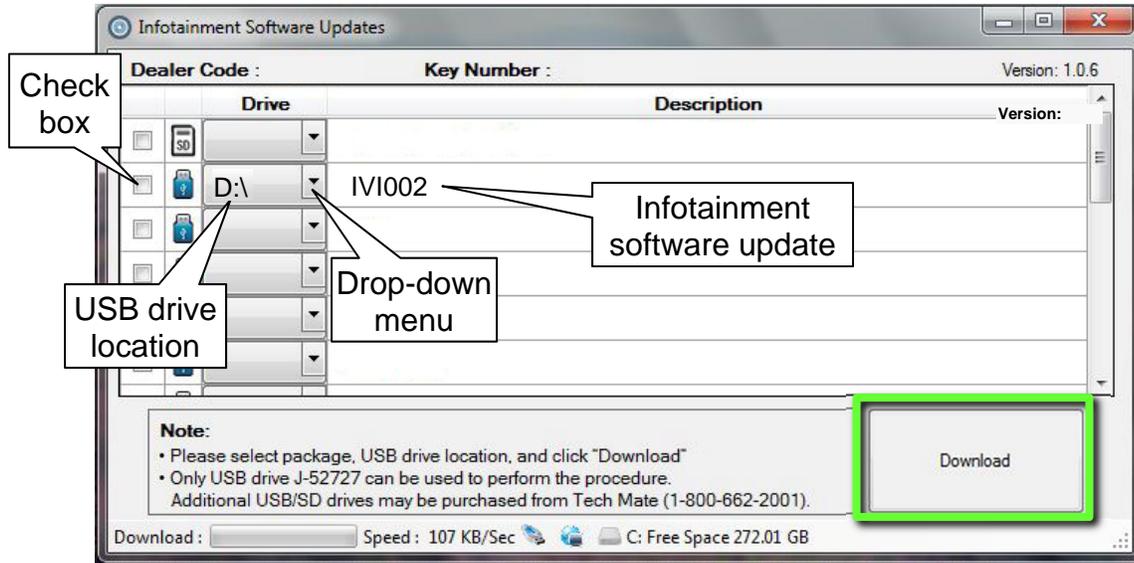
8. Select the check box next to the **IVI002** infotainment software update (refer to Figure 8 below).
9. Use the drop-down menu and select the location of the USB drive that was inserted in step 5.

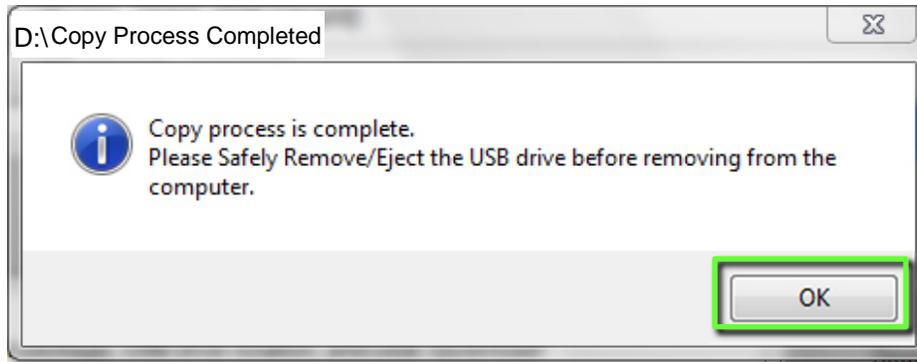
Figure 10

11. Select **OK**.

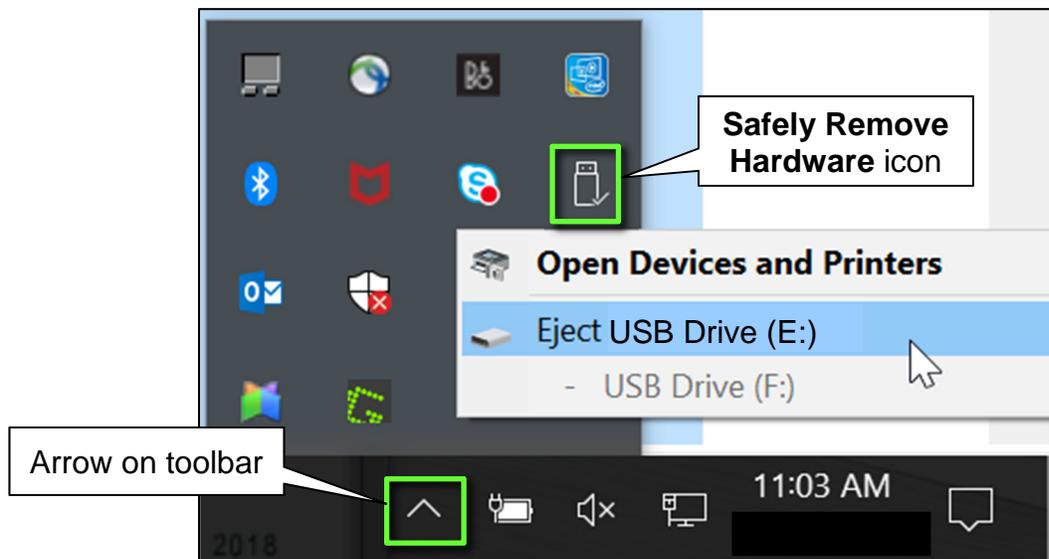
Figure 11

12. Once the transfer is complete, safely remove the USB drive from the ASIST Station.

- a. From the PC toolbar, select the **Safely Remove Hardware** icon.
  - The icon is on the toolbar, or can be found after selecting the arrow.
- b. Select the USB drive to be removed, and then remove the USB drive from the ASIST Station.

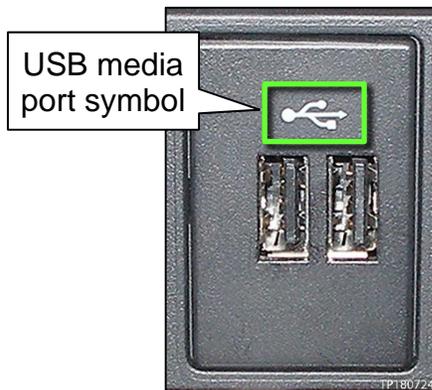
Figure 12

16. Insert the USB drive with infotainment update software into the vehicle's USB media port (see Figure 12).
- Do not remove the USB drive during the update to the vehicle until instructed to.

**HINT:** Charging ports are marked in the vehicle with a “lightning bolt” symbol.

**NOTICE** Do not insert the USB drive into a charging port. If used, the update software and/or USB drive may become damaged. Only insert the USB drive in a USB media port.

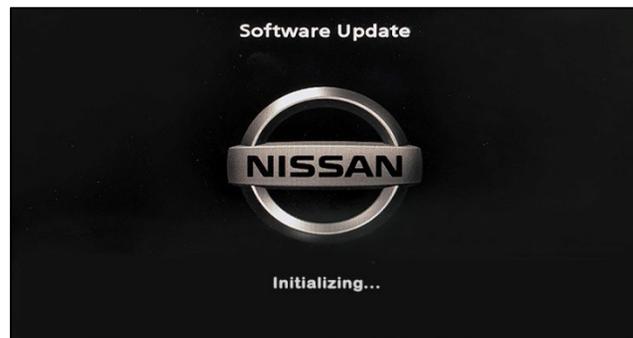
17. Wait approximately 10-30 seconds for the screen in Figure 14 to appear.

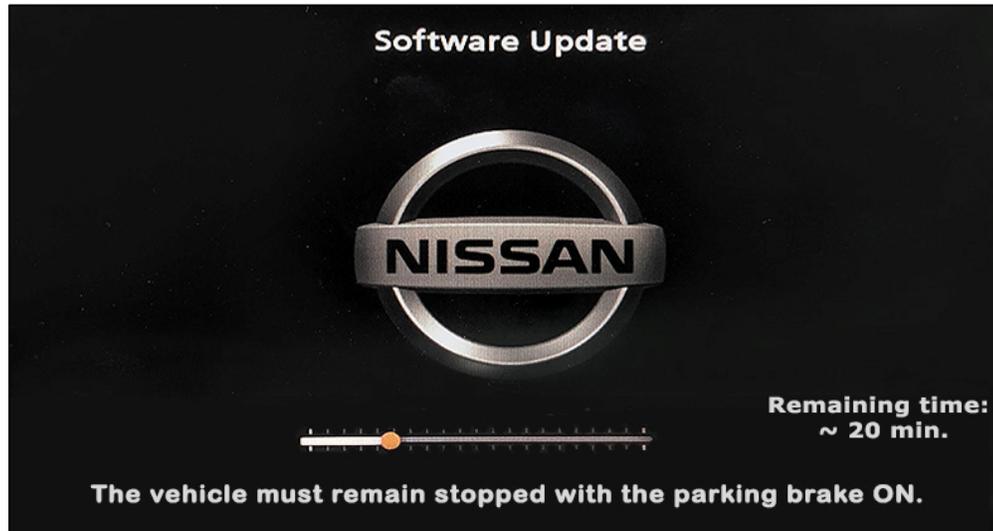
Figure 16

18. Wait for the update to complete.
- Follow the on-screen instructions while waiting.
- HINT:** The update lasts 15-25 minutes.

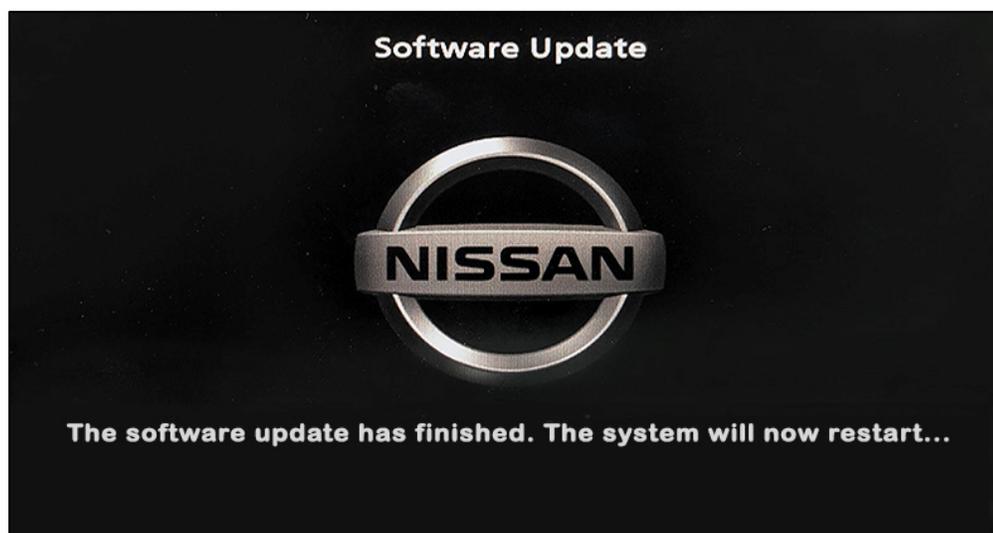
Figure 17

19. Once the update is complete (Figure 17), remove the USB drive; the system will reboot (restart).
- HINT:** The system will not reboot until the USB drive is removed.

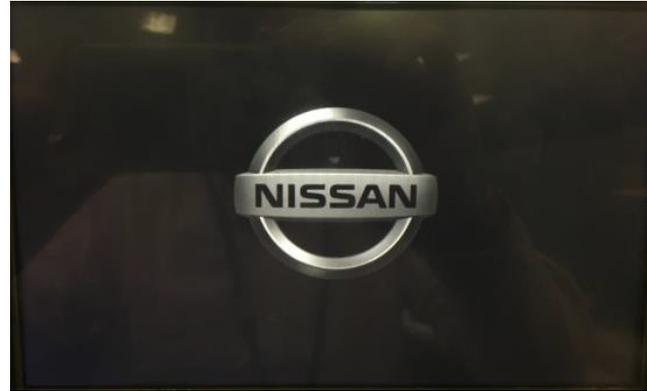
Figure 18

20. Allow the reboot to complete (approximately 30 seconds).
  - The Nissan logo will be displayed during the reboot.
21. Turn the ignition OFF.

24. Turn the ignition ON (engine OFF) and wait for the Nissan logo to appear (Figure 18).
  - If the Nissan logo does not appear (this might take up to 30 seconds), start over from step 21.

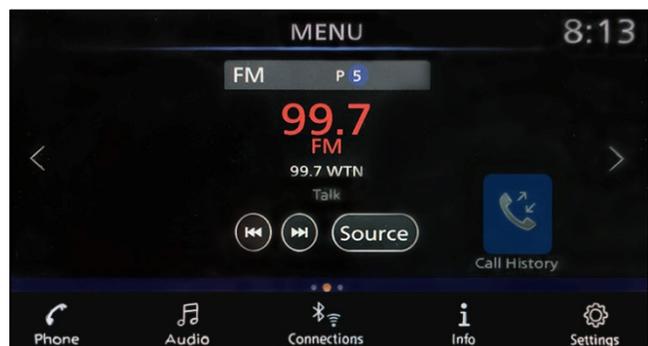
25. After the Nissan logo appears, wait about one (1) minute.
  - The MENU (Home) screen in Figure 19 will be displayed.
